9th International Masonry Conference 2014 in Guimarães

Investigating the durability of FRP-masonry elements immersed in water

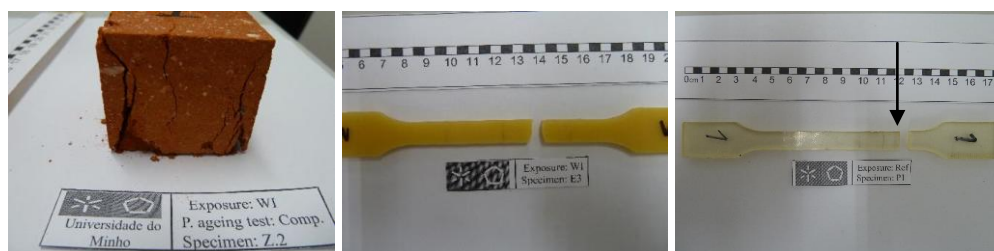
Figure 3. Typical failure mode of brick, epoxy resin and primer

The compressive strength of masonry bricks were obtained according to standards UNI EN 1015-11 (2007) [15] and ASTM C67-12 [16]. The tests were performed on 40 mm brick cubes in the flatwise direction under force controlled conditions with a constant rate 150 N/min.

The mechanical characteristics of epoxy resin and primer were determined by performing tensile tests on dog-bone shape specimens cured in laboratory conditions for two months, following ASTM D638 (2010) [17]. The tests were performed under displacement controlled conditions with a constant rate of 2 mm/min.

The typical failure modes of the specimens after performing the mechanical tests are presented in Figure 3 and Figure 4. The mechanical properties of materials together with coefficient of variations of the results are presented in Table 1.

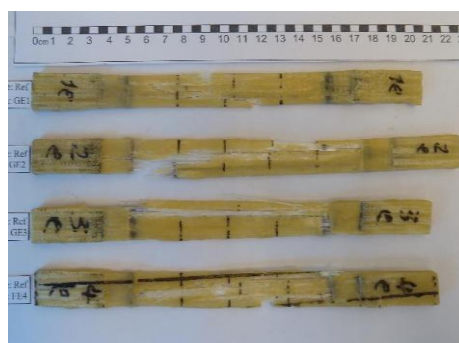
Figure 4. Typical failure mode of GFRP coupons

The tensile strength and elastic modulus of GFRP were also obtained by conducting tensile tests on GFRP coupons, prepared following the wet lay-up procedure, based on ISO TC71/SC 6 N (2003) [18] and ASTM D3039 (2008) [19]. The tests were performed under displacement controlled conditions with a constant rate of 2 mm/min.

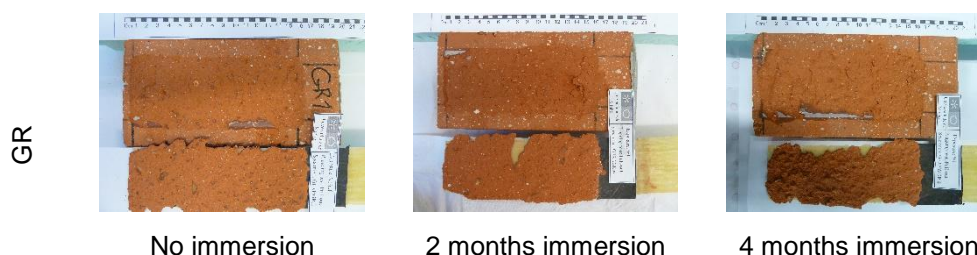
Figure 9. Changes of failure mode with water immersion

The influence of water immersion on the failure mode of the specimens can be clearly observed in Figure 9. The change of failure mode from cohesive to adhesive was the main effect of water on the ORG-specimens. Nevertheless, the mode of failure in GR-specimens was not changed and remained cohesive in the substrate in all the immersion periods. However, the thickness of the remained detached brick on the GFRP sheet was observed to decrease with time.
